COMMERCIAL WINDSTORM MITIGATION REPORT

Seville Condominium No. 4, Inc.

COMMERCIAL WINDSTORM MITIGATION REPORT (OIR-B1-1802)

1012 Pearce Dr, Elevator Building

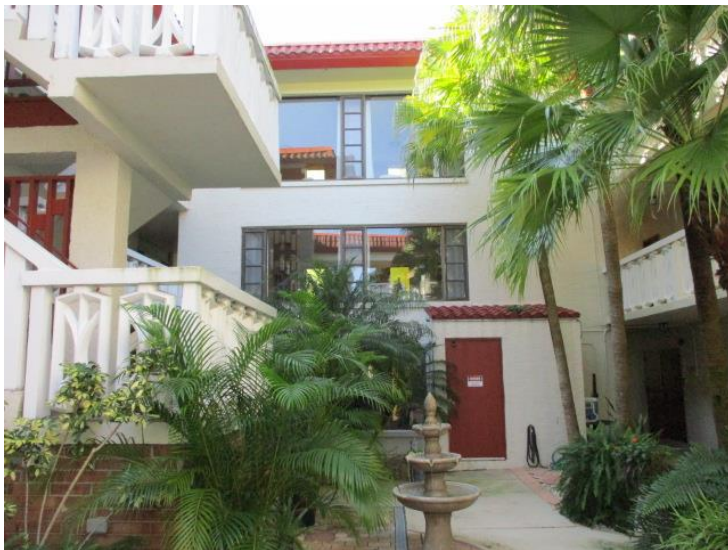
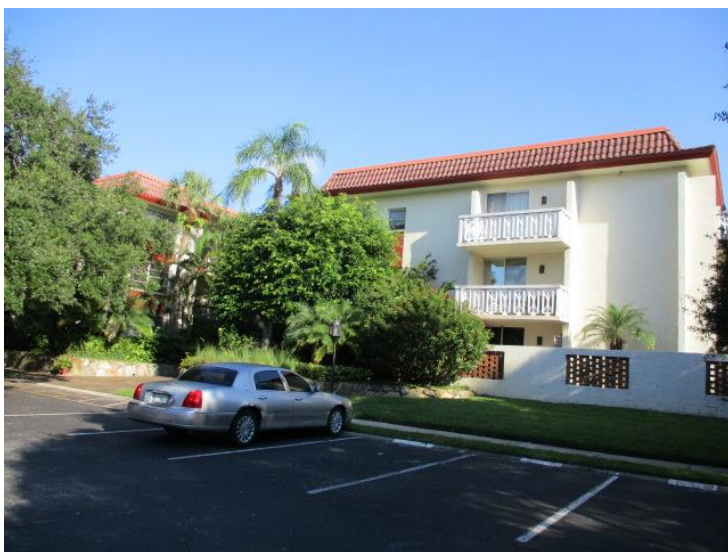
Exterior Elevation

7. **Opening Protection:** **None or Some Glazed Openings**
Comments: Inspection verified some metal shutter opening protection. Not all glazed openings were protected with impact resistant coverings.

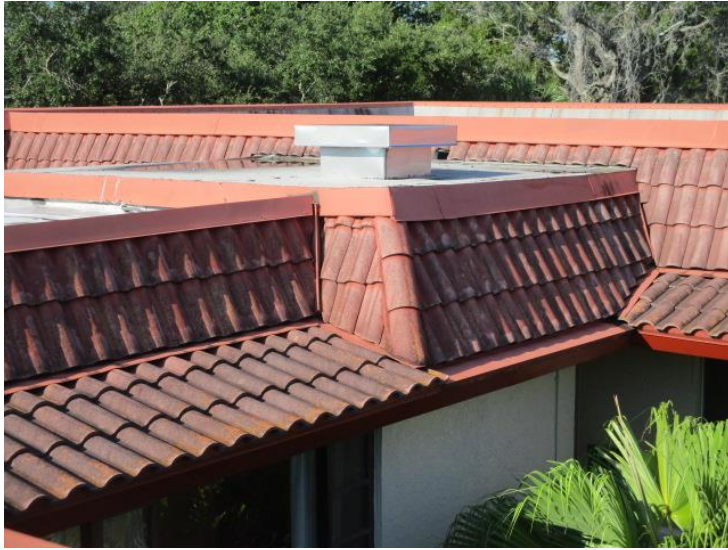
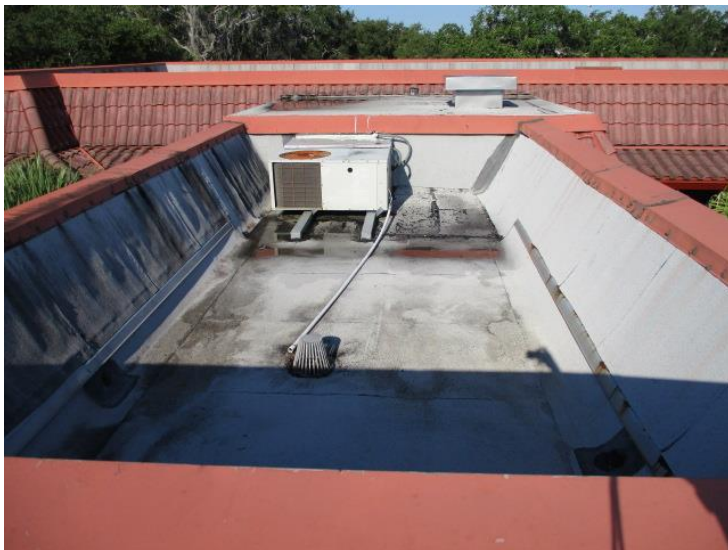
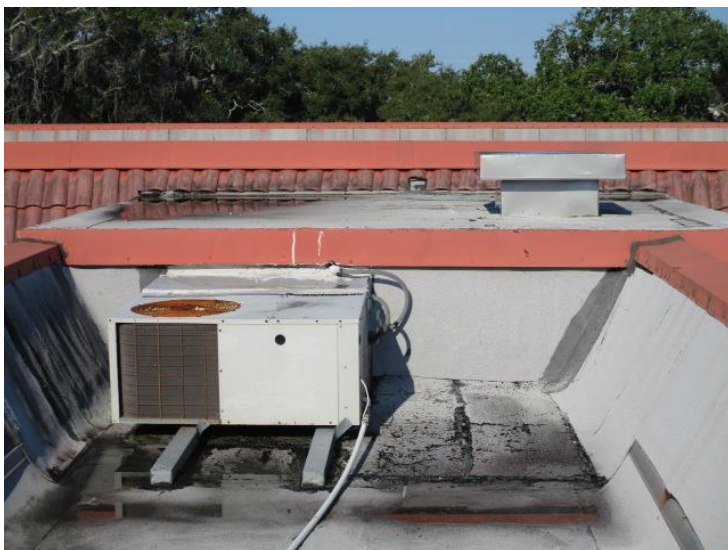
Roof Construction

3. **Roof Deck Attachment:** **Other**
Comments: Inspection verified a roof deck composed of lightweight concrete poured in metal pans supported by metal bar joists.

4. **Roof to Wall Attachment:** **Structural**
Comments: Inspection verified a roof-wall connection composed of steel bar joists structurally connected to the wall/support system.

5. **Roof Geometry:** **Flat Roof**
Comments: Inspection verified a flat roof shape.
6. **SWR:** **No**
Comments: At the time of inspection, no SWR was verified.

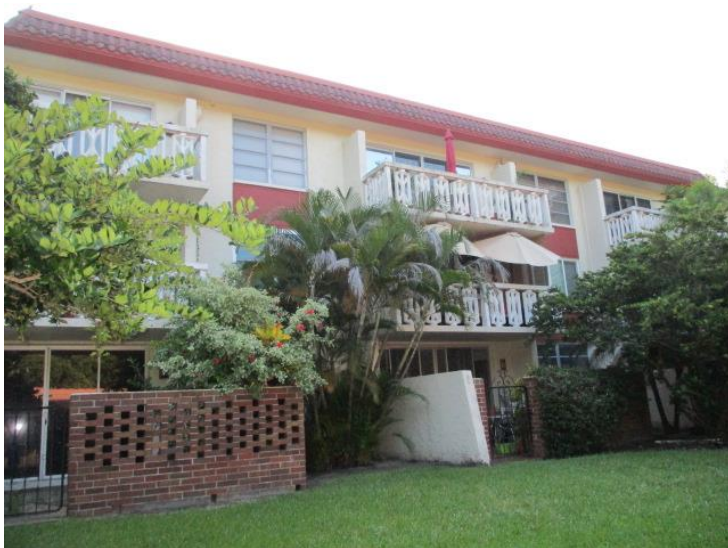
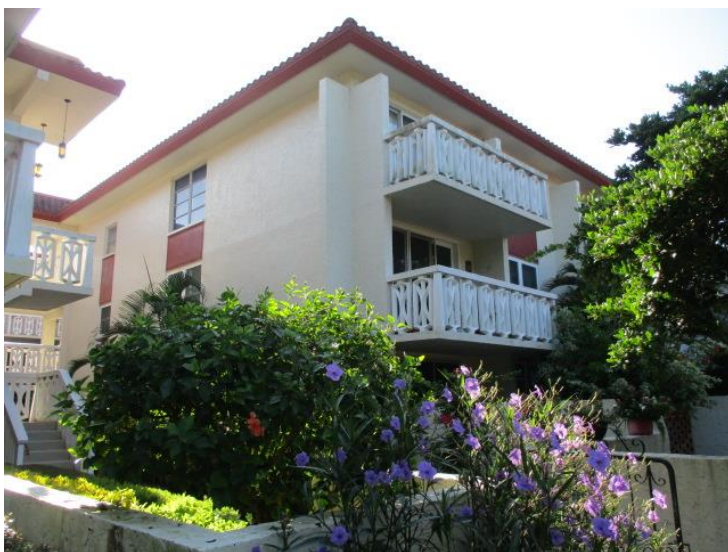
Exterior Elevation

7. **Opening Protection:** **None or Some Glazed Openings**
Comments: Inspection verified some metal shutter opening protection. Not all glazed openings were protected with impact resistant coverings.

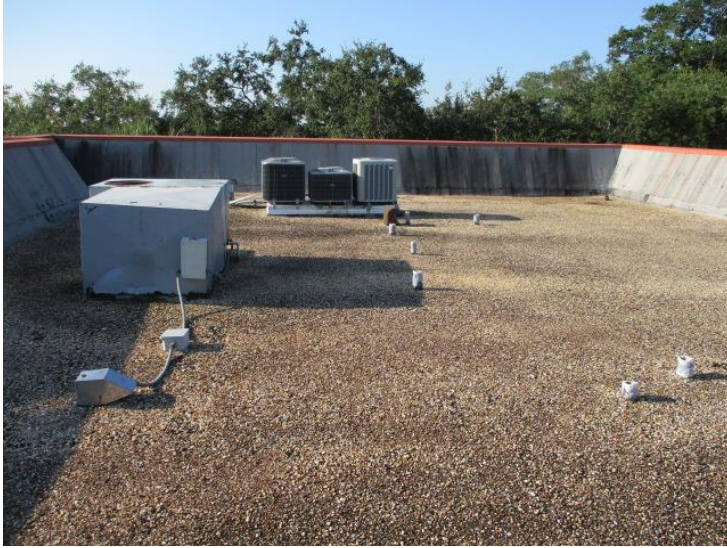
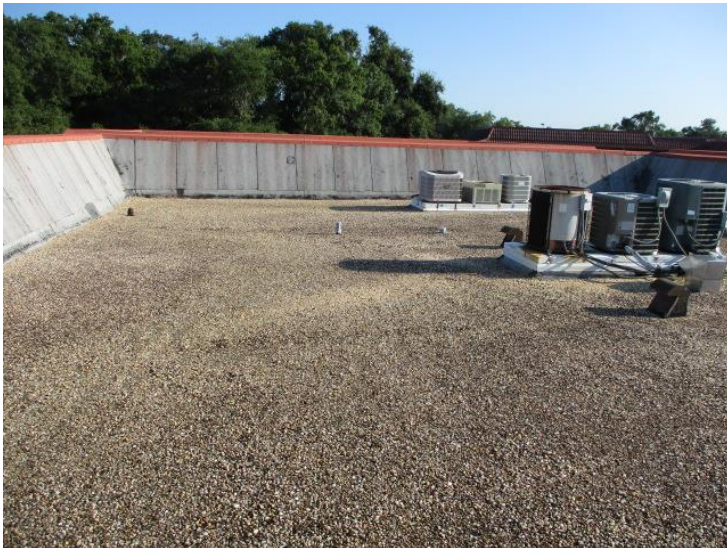
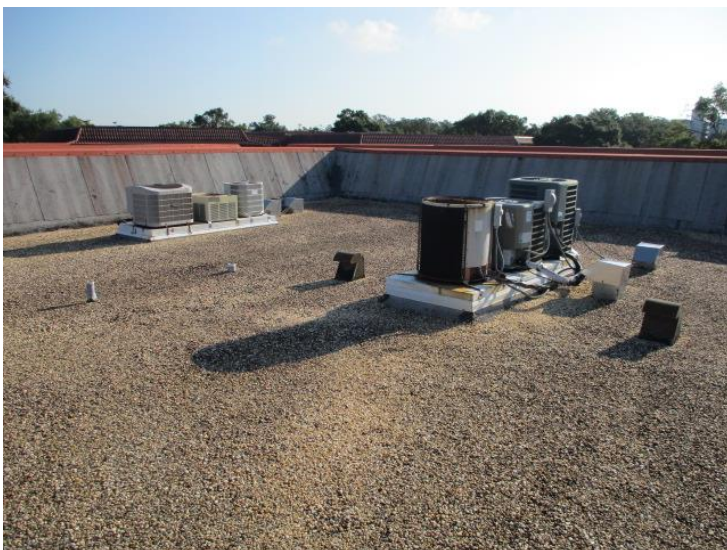
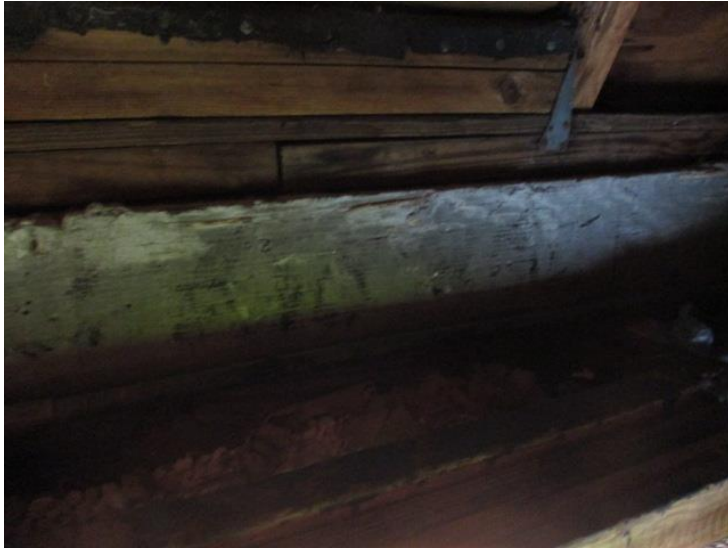
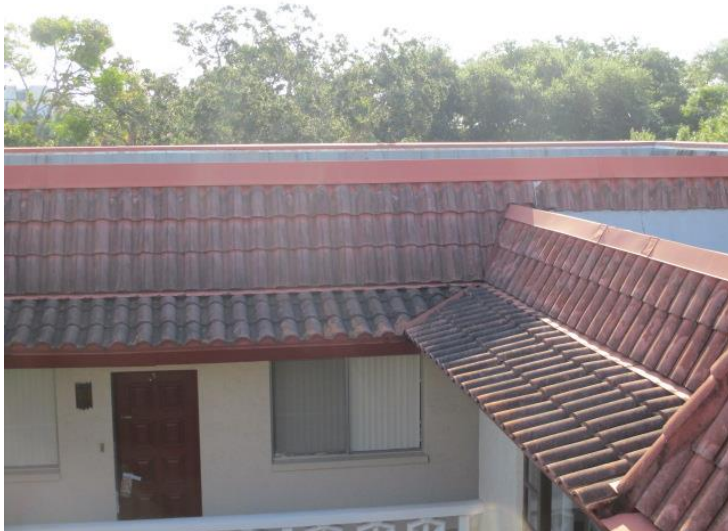
Roof Construction

2. **Roof Covering:** **FBC Equivalent**
Comments: The roof covering was replaced in 2003. The roof permit was confirmed and the permit number is BCP2003-06103. This roof was verified as meeting the building code requirements outlined on the mitigation affidavit.

5. **Roof Geometry:** **Flat Roof**
Comments: Inspection verified a flat roof shape.
6. **SWR:** **No**
Comments: At the time of inspection, no SWR was verified.

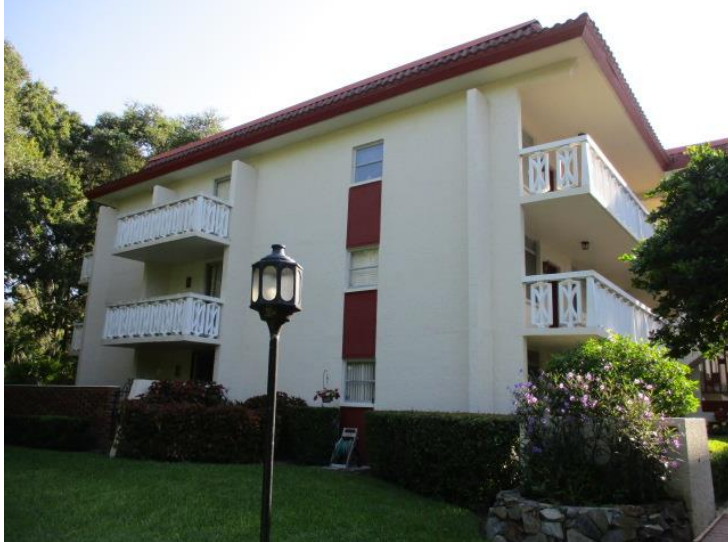
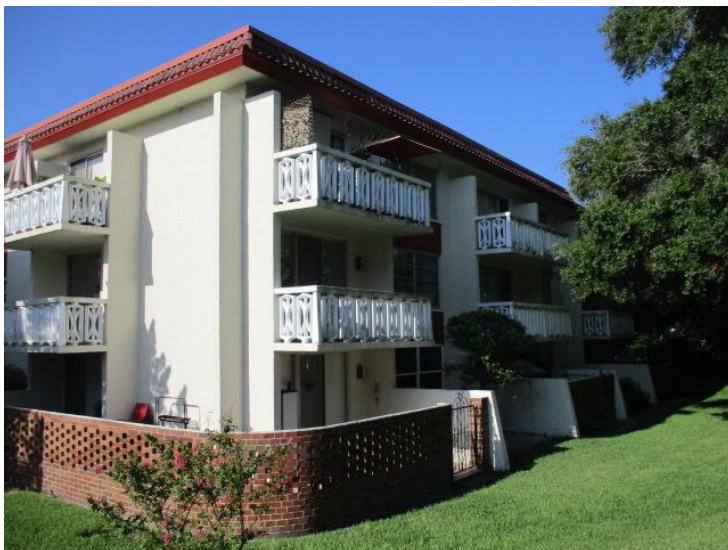
Exterior Elevation

7. **Opening Protection:** **None or Some Glazed Openings**
Comments: Inspection verified some metal shutter opening protection. Not all glazed openings were protected with impact resistant coverings.

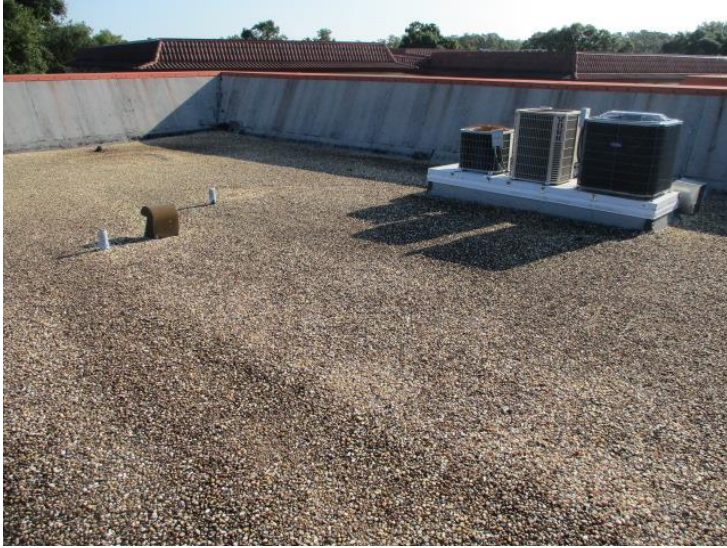
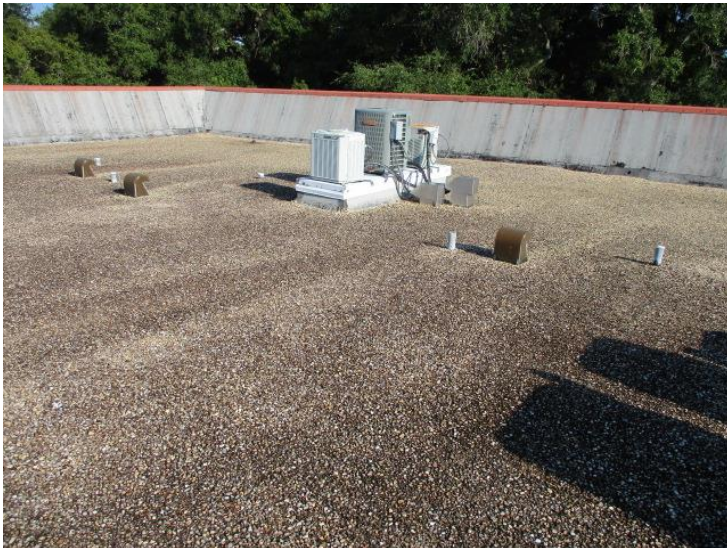
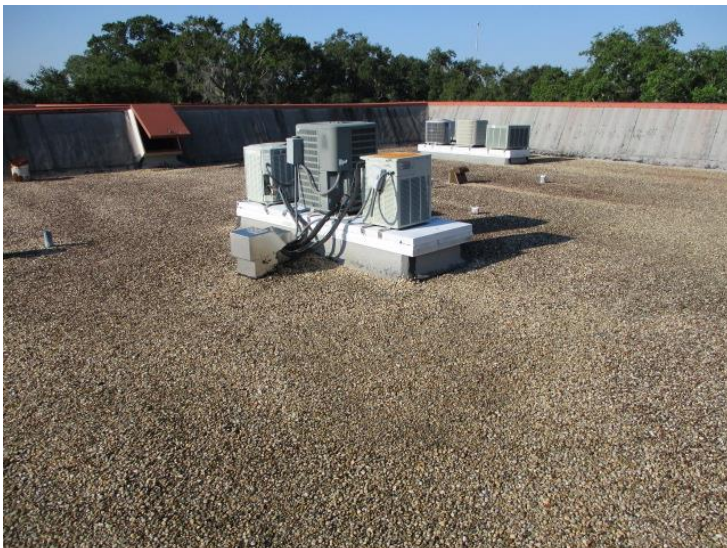
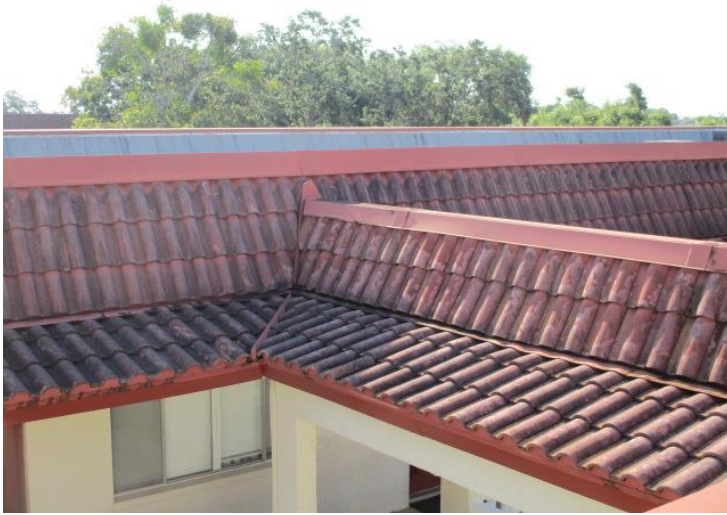
Roof Construction

2. **Roof Covering:** **FBC Equivalent**
Comments: The roof covering was replaced in 2003. The roof permit was confirmed and the permit number is BCP2003-06103. This roof was verified as meeting the building code requirements outlined on the mitigation affidavit.

5. **Roof Geometry:** **Flat Roof**
Comments: Inspection verified a flat roof shape.
6. **SWR:** **No**
Comments: At the time of inspection, no SWR was verified.

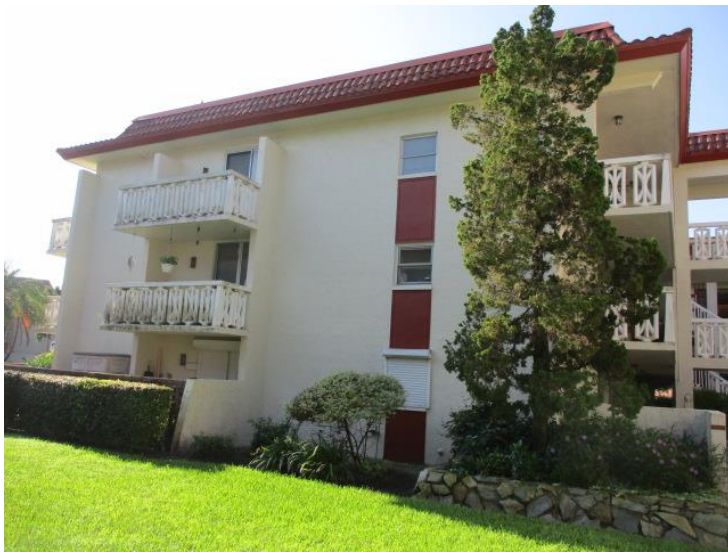
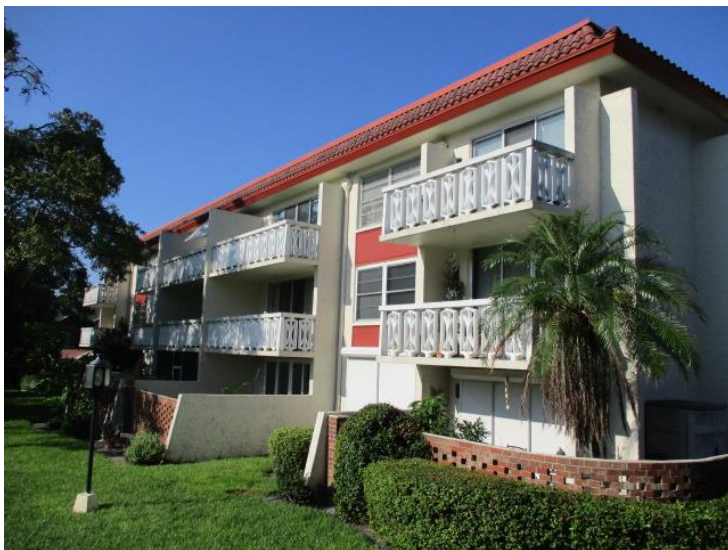
Exterior Elevation

7. **Opening Protection:** **None or Some Glazed Openings**
Comments: Inspection verified some metal shutter opening protection. Not all glazed openings were protected with impact resistant coverings.

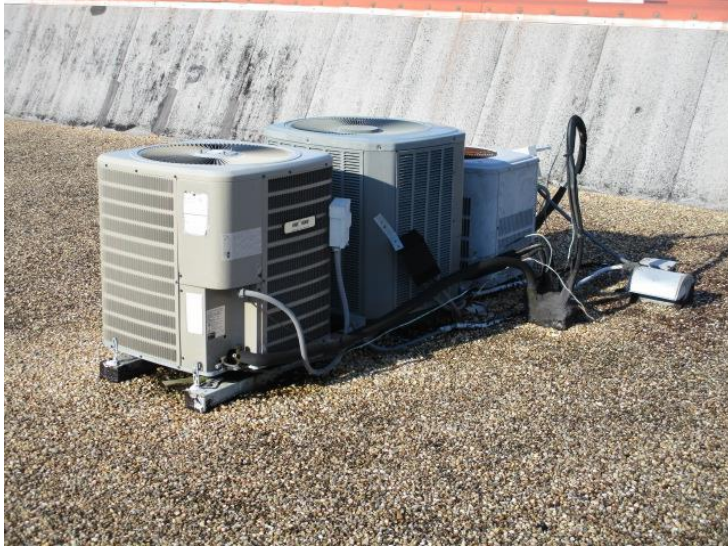
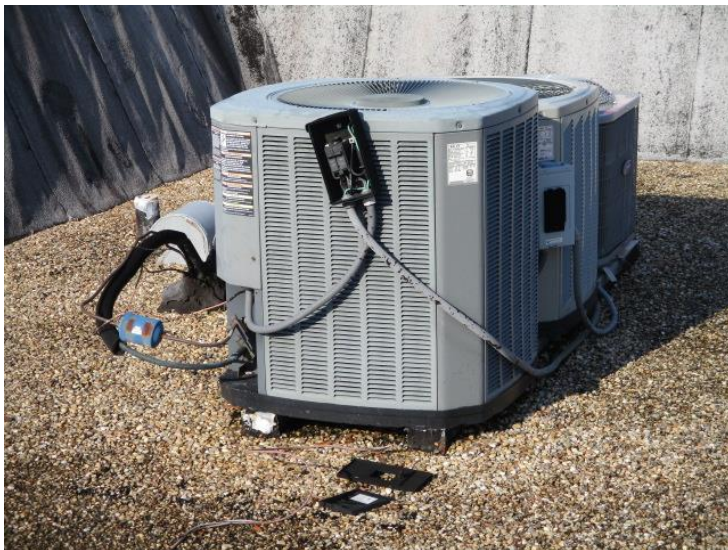
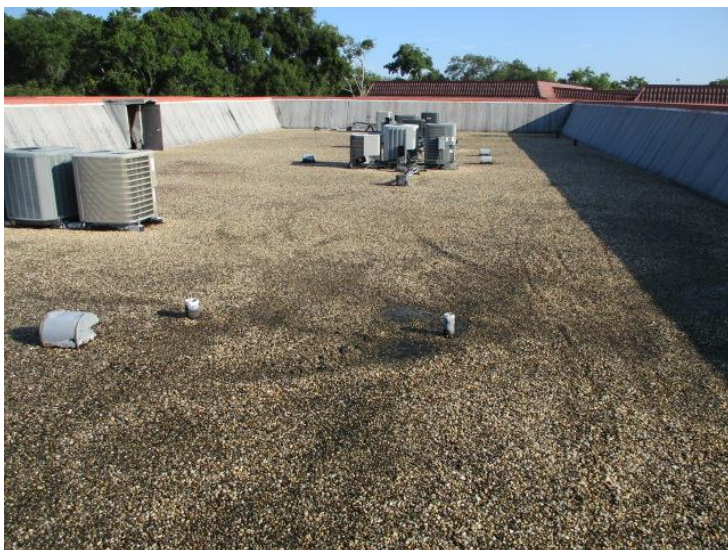
Roof Construction

2. **Roof Covering:** **FBC Equivalent**
Comments: The roof covering was replaced in 2003. The roof permit was confirmed and the permit number is BCP2003-06103. This roof was verified as meeting the building code requirements outlined on the mitigation affidavit.

5. **Roof Geometry:** **Flat Roof**
Comments: Inspection verified a flat roof shape.
6. **SWR:** **No**
Comments: At the time of inspection, no SWR was verified.
